Record of Concern/Record of Response for October 27, 2006

Summary

This record is being drafted to document concern for environmental impacts associated with construction activities on the Falls Creek Hydro-electric project. Blasting in recent weeks has resulted in 4 slides into Falls Creek. The first slide occurred on October 6th and the most recent slide occurred on October 22nd. The slides have had minimal-moderate immediate impacts on fish habitat, however, slope instability and the threat of further mass wasting is a serious concern in all areas, including blasting areas scheduled for the near future. Two of the slides at the powerhouse area had direct impacts to anadromous fish habitat that may necessitate mitigation. Each of the 4 slides occurred as a result of bedrock blasting for service road construction. Each of these shots were conducted under circumstances where nothing, or a very narrow protective berm existed between the planned shot and the Falls Creek canyon wall. For the purposes of this report these type of shots will be referred to as “daylight shots” (see figures 1 and 2). *A preliminary report on the first two slides was provided via e-mail (including photos)

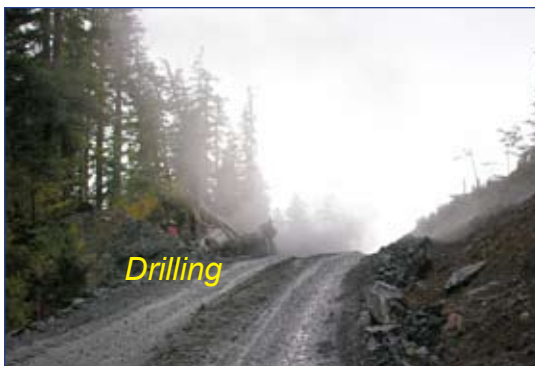
The first slide into the creek occurred at the Blueberry Hill road cut area on October 6th (see figure 3.1). A previous record of concern was filed in July when road construction activities first began in this area (see Appendix 2 of the July report). Part of the record of response from the project manager and construction superintendent was to propose moving the road back from a bench cut at the canyon wall to a trench cut approximately 40 feet from the canyon wall (see figure 1). Vegetation, topsoil and bedrock were not disturbed along the canyon wall leaving a large berm between the blasting of the road and the canyon wall. Avoidance of daylight shooting here appears to have worked well for reducing the likelihood of mass wasting in most of this area, however, it was eventually necessary to daylight out into the neighboring valley in order to continue with the intake road up toward the impoundment.

Slide 1 into the creek resulted in a narrow band of the forested slope giving way immediately below the daylight shot and dumped topsoil, trees and rock from the blast down the ~ 200' canyon walls to Falls Creek (see figures 3.1, 3.2, 3.3, 3.4, 3.5). Turbidity was tracked following the event with a peak of 31 NTUs occurring about an hour after the shot. Immediate impacts to fish habitat were minimal.

Figure 3.1: Elevation model for the area around the Blueberry Hill road cut. Two slides have occurred in this area: one back in July and one in October.

The greatest concern I have for this area is that slope disturbance from this slide may lead to further unravelling and sliding of nearby steeply forested habitats. There are potential marbled murrelet nesting trees in this forest and further slide could temporarily dam the creek below and contribute to increased downstream turbidity. No mitigatory actions have occurred thus far. I am currently recommending that work with matting, vegetation and runoff control be done to stabilize and protect the disturbed slope.

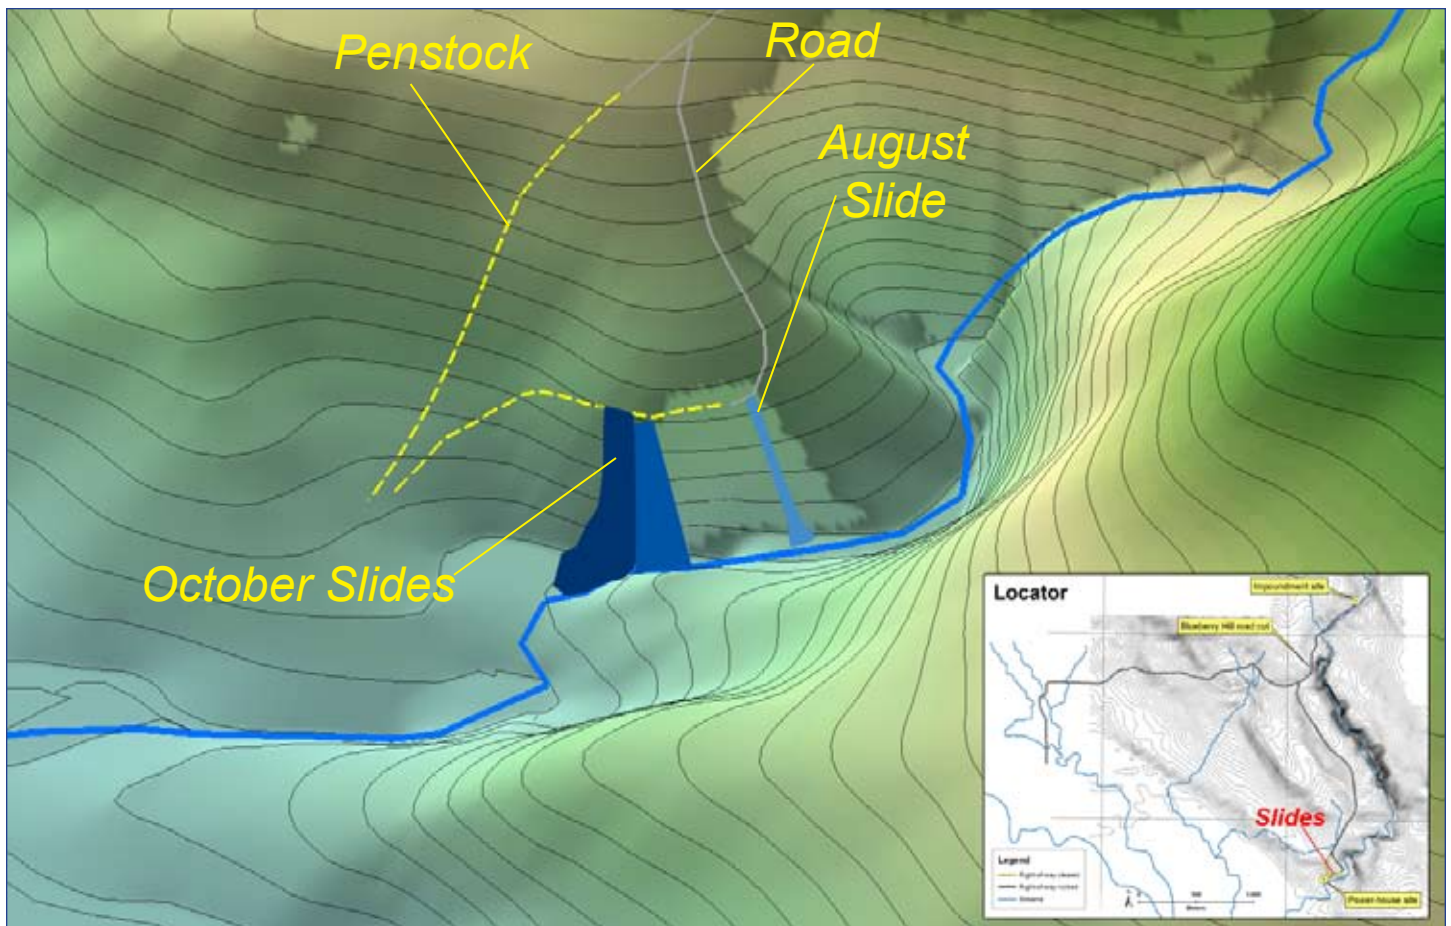
Slide 3 into the creek occurred at the powerhouse site on October 19th (see figure 4.0, 4.1, 4.4 and 4.5). Like the slide at Blueberry Hill, this slide also occurred as a result of a daylight shot that was at least partially unavoidable as the road was coming out of the bench cut corner above Falls Creek to descend into the powerhouse valley. Slide 3 occurred in two parts: 3.1) the forested slope immediately between the shot and Falls Creek slid down into the creek, and 3.2) the “topsoil” in the powerhouse valley gave way and slid into the creek when loaded with shot rock. The blasting plan for this area was to lift and throw the rock away from the canyon wall and into the powerhouse valley. The shot went according to the plan but the forested slope was shaken enough to still result in slide 3.1 and the down slope loading of the powerhouse valley unexpectedly resulted in slide 3.2.

Figure 4.0: Aerial view of the powerhouse area that shows the August slide and the locations impacted by slide 2 and slide 3.

Slide 3 into the creek was the largest thus far and resulted in approximately 2,500 yards of topsoil and shot rock covering the creek, as well as several logs and trees. Although potential spawning gravels were not mapped in this location in 2000, recent photos indicate that potential spawning gravels, especially for coho salmon, were likely present in the area now covered by the slide (see Appendix 1 for a figure excerpted from Flory 2000, Resident Dolly Varden, Anadromous Fish Species and Benthic Invertebrates of the Falls Creek Area, part of the PDEA). The impacted area included an island in the center of the stream and a channel along the east side of the island. The terminal lobe of the slide now rests on top of this island and the channel on the east side was completely buried. No mitigatory actions have occurred thus far. Jackie Timothy of the DNR met with me and the project manager on-site to assess impacts and begin a discussion on possible mitigation actions. Plans for mitigation are ongoing and will be described in further detail in a subsequent report.

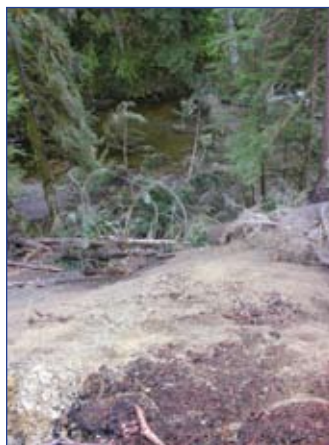
The second slide into the creek occurred at the powerhouse site on October 12th just downstream of the slide reported in September (see figure 4.0, 4.1, 4.2 and 4.3). Though there was a small berm between the shot and the canyon wall the material was largely topsoil and rotten rock and provided little protection of the slope from the blast. This section of the road could have been moved further from the canyon wall after the slide that occurred in September provided a “heads-up” on how unstable this area was but this would have greatly increased the cost of this section of road and would not have guaranteed that no mass wasting would have occurred in this area. Following consultation with the project manager and construction superintendent it was decided that the situation would be handled by modifications of the blasting plan. In particular, the depth of drilling and the amount of explosives used were reduced and lookers were employed for relief.

Slide 2 into the creek resulted in a relatively small amount of topsoil and a few trees entering the creek. Immediate impacts to fish habitat were low with just a small area of potential salmon spawning gravels buried and very little turbidity measured in the aftermath. As with the slide at Blueberry Hill my greatest concern for this area is ***that slope disturbance from this slide may lead to further unravelling and sliding of nearby steeply forested habitats.*** To some degree this concern has been made a moot point because the forested slope downstream of slide 2 was lost as a result of another daylight shot in this area and slide 3 into the creek. No mitigatory actions have occurred thus far. I am currently recommending that work with matting, vegetation and runoff control be done to stabilize and protect the disturbed slope.

Figure 4.3: View from the top of slide 2 into the creek. This slide covered a small area of potential spawning gravels and briefly increased downstream turbidity. Fish habitat was impacted here.

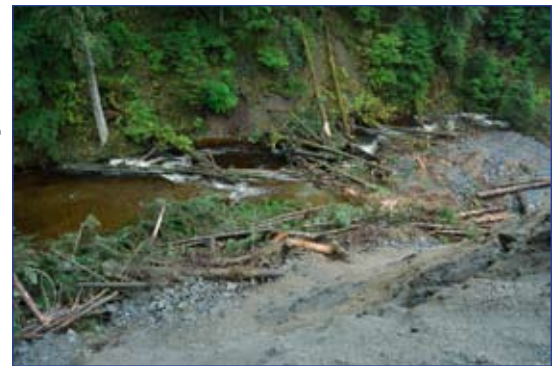
Figure 4.4: View from the top of slide 3. The topsoils, rock and trees in the foreground are at the terminus of the first part of slide 3 - 3.1. Fish habitat impacted.

The last shot, which was to "daylight" the road into the powerhouse "valley", was to contain the lightest load of all the powerhouse shots. The blasting plan was to move the rock forward into the valley. The shot went according to plan, however most of the remaining slope to the creek gave way. The ravine that received most of the rock that was shot forward slid into the creek with the additional weight of the rock.

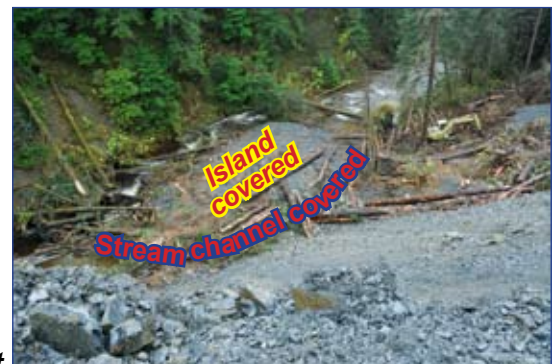
Figure 4.5: View from the top of slide 3. The rock and log pile down in the creek is from the second part of slide 3 - 3.2. Fish habitat was impacted here.

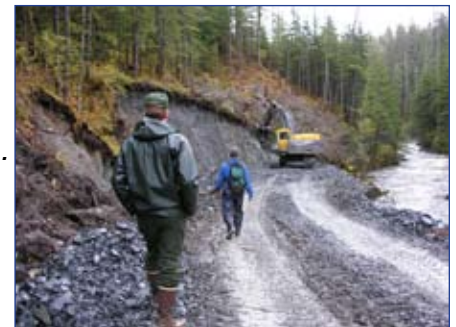
Figure 5.3: This picture was taken ~ 500' upstream of slide 4 and provides a good view of the area that needs to be blasted to make penstock grade. Road at right must come down 10-15'.
